# Broadcasters' Desktop Resource

## The Worst I've Ever Seen! The Tower Leg that Just "Melted"

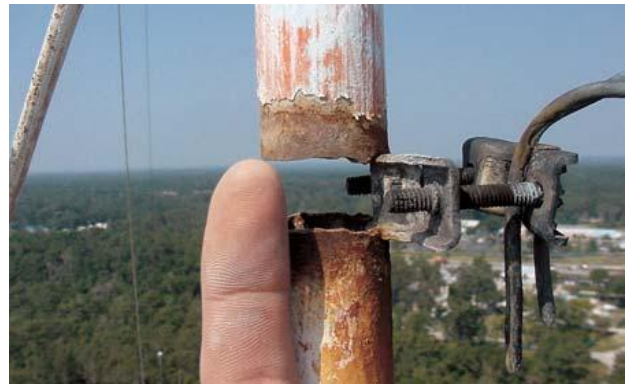
As the climber got closer, the view became even less appetizing. It indeed *was* what he thought he had seen – a rather nasty gap in the leg.

**This tower leg wasn't designed to have a window**

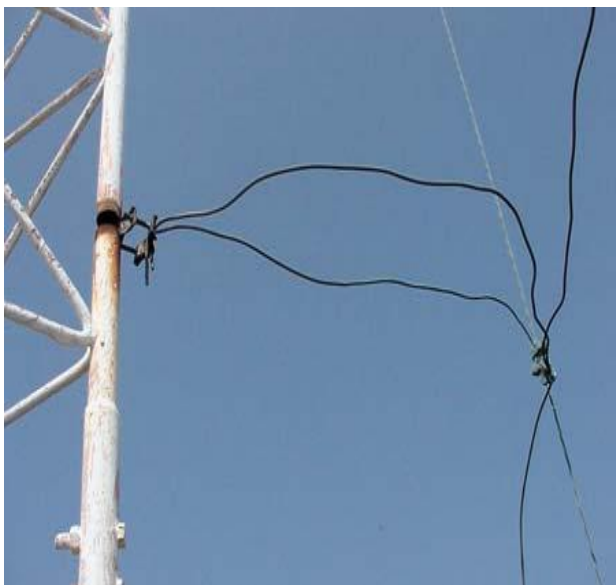
As you can see from the condition of the tower and paint, over a long period of time, something "ate away" the metal.

**One of those truly  
"it is hard to believe your eyes" situations**

Obviously, the electro-chemical reaction, aided by the pull of the unipole supporting wires did a good imitation of a hot knife going through butter.

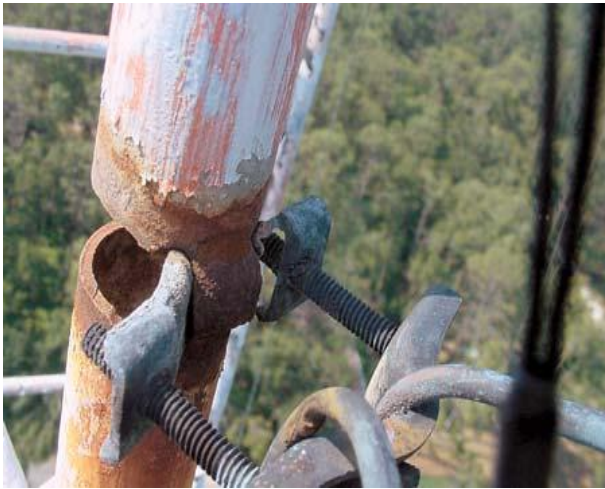
By the time when these pictures were taken, only the bracket itself was holding the tower leg in place.

**Only a tiny, buckled bit of the tower remained**

It was only a small gap, obviously hard to see from ground level. But with only a tiny, buckled bit of the tower leg remaining, the gap would have been more than large enough to bring the whole tower down if any stress from high winds, for example, had occurred.

Barber relates that the climber stopped what he was doing and got off the tower immediately. Repairs to the tower were carried out shortly

thereafter, and at last report, the structure was stable.
