Broadcasters' Desktop Resource

The Worst I've Ever Seen!

This time we have some new pictures taken at the base of one of the towers in a AM station's directional array. They put on display one of the most common issues we see: what is inside the tower fence.

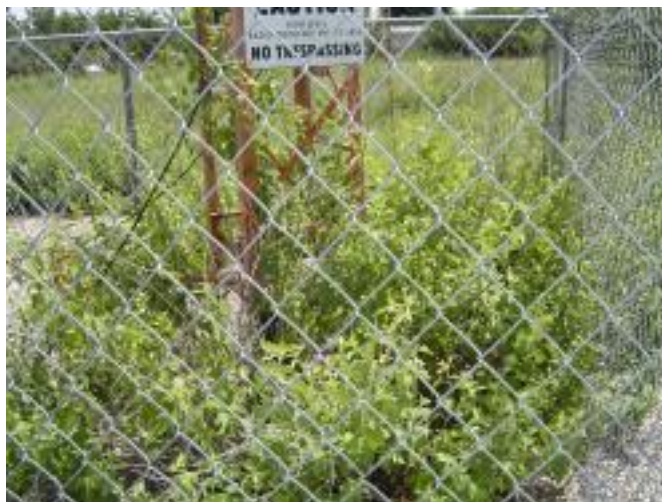
It looks like there is a bit of a jungle in there!

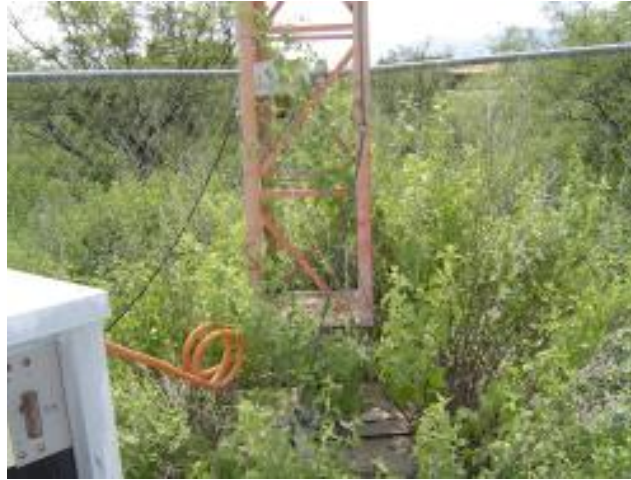
Electronically, there is the potential for the growths to get into the lightning gap, or worse, create a sort of ground path for the RF being fed to the tower.

Eventually, when there is enough growth, it can even shunt power to ground

No, this engineer did not start turning the cranks to bring the array back to “normal.” Instead, he cut the brushes, weeds, etc. And, he tells us that as soon as the weeds and shrubbery were pulled back, the array went to normal.

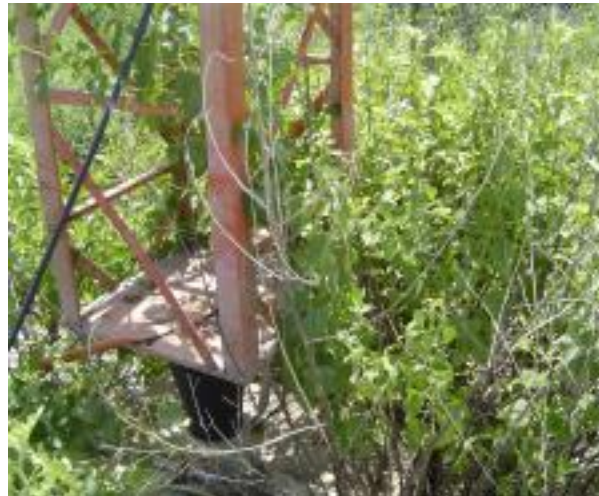
No question - it was a jungle in there

By the way, we did not ask and therefore do not know whether there is a requirement for tower painting and lighting. But if there is, it would appear the paint is long gone. At the least, it exposes the tower itself to deterioration.

In fact, in only a slightly facetious way, the engineer concluded, “It seems engineers should keep a set of pruning shears and a weed eater on hand when in the field.”
