Broadcasters' Desktop Resource

The Worst I've Ever Seen! **You Cannot Fight the Storm**

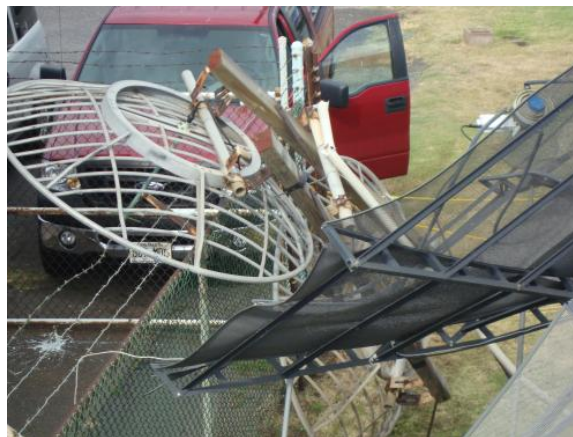
A nasty storm caused two STL dishes to fall down through the satellite receive dish

Welcker relates: “Basically there were two Mark dishes and a whip mounted on wooden cross members on top of a pole. Due to high winds the mounts worked themselves free falling through a paraflector, then through the satellite dish below all that.”

Can we learn any lessons from this situation? Perhaps it is good to periodically review the condition of the STL and receive dishes used at a facility. Sometimes they can be strengthened, sometimes there is little that can be done, aside from making sure that if they break free, they will likely fall where they will not do damage to buildings or people.

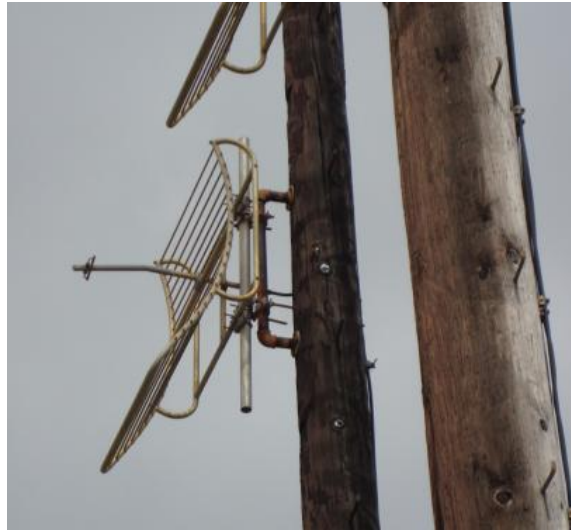
Two dishes remained attached to the poles but the ones that fell killed the satellite receive dish.

Curiously enough, one of the Mark dishes was feeding an AM station about eight miles away. Welcker was amazed to hear that despite some static, and the loss of the dish ripping “the inner out of the feed when it fell, just the transmission line and part of the inner [was left hanging] and it was still being picked up on the receive side. There was static as the wind would blow the cable past a pipe mount, still on the pole. Amazing how those things work.”

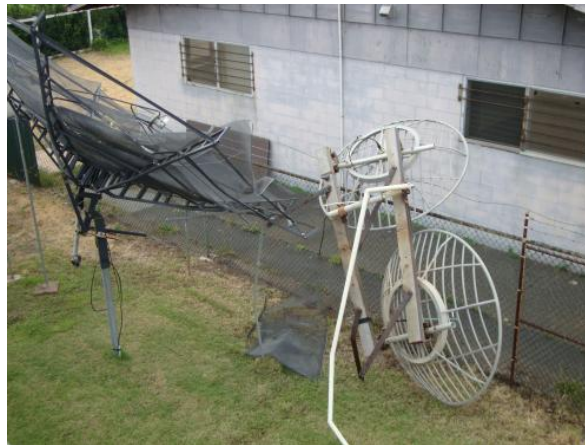
Viewed from another angle, not only is the damage visible, but we can see how close it was to where it might have hit someone.

At least the timing was good for the safety of the station personnel. As Welcker relates: “Luckily no one was around so there were no injuries, no damage to the building either, just equipment.”
