The Worst I've Ever Seen!

The Auxiliary Antenna that Wasn't

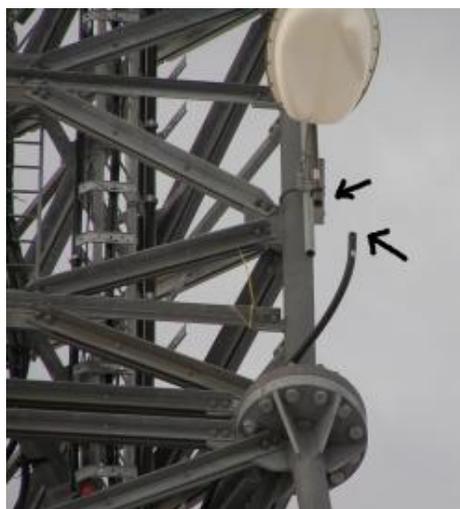
John Dehnel shares this experience with us. “We recently tried to switch on to KRSP-FM’s auxiliary antenna. It would not work.

“After investigating we found out why.”

The line to this aux antenna was not continuous

Reminders like this remind us all that we should schedule regular, routine inspections of even the least-used parts of our facility. You never know what you will find, but it sure could save you from unexpected problems when you least need additional things to worry about.

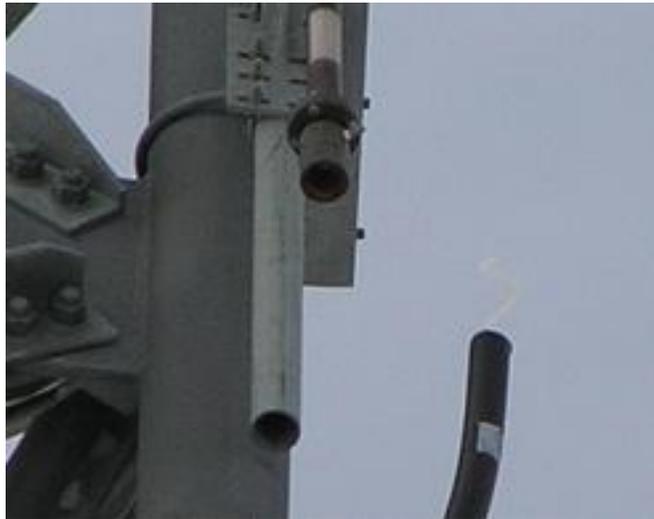
“The pictures show our little problem. Now, look closely! Is that KRSPs signal coming out of the ripped-out feedline?”

Look closely; it almost looks like the RF is trying to escape

“Actually it was a jet stream from an airplane passing overhead. Right place, right time!”

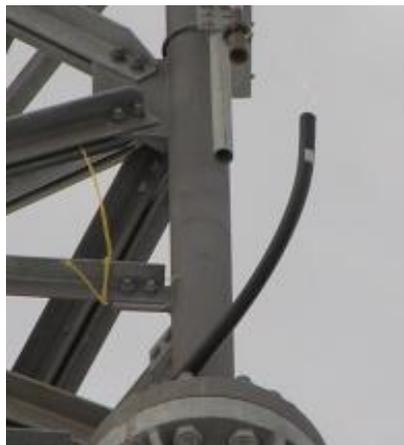
Tie a yellow ...

Dehnel relates that although they do not know exactly when the cable was pulled out of the connector, the antenna *was* tested not long ago. On the other hand, reviewing the possibilities – including ice on the tower – there was a clue.

Just to the left of the coax, you will notice some yellow rope attached to the tower. As Dehnel points out: “... there had recently been some climbers on the tower removing a retired VHF television antenna which was mounted above the FM. They may have stepped on it. We don’t know for sure. ... But the yellow rope is suspicious.”

While most climbers are careful, accidents can happen, especially on crowded towers. A misplaced foot, a dropped tool, etc, can easily damage something that is unrelated to the work being done. In situations where something is not used regularly – like an auxiliary antenna – it might be months (or more!) before the problem is even detected.
