The Maintenance Shift

A Real World Justification for Regular Testing

By Burt Weiner

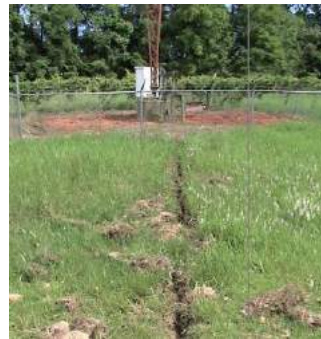
I was pointing to the nice rows of fresh dirt where the radials of one of the towers had been pulled up.

Further investigation revealed that most of the ground system from one of the towers had been pulled up, as well as most of the copper strap between that tower and the building, including the copper strap that went around the building that tied into the other site ground radials.

No one wants to see something like this, where the copper has left the ground

We had the ground radials and copper strap replaced by the original installer. The antenna monitor did not change, but the nighttime monitor points returned to their original proofed readings.
