# Broadcasters' Desktop Resource

## The Worst I've Ever Seen!

### The Lock is Not the Focus

*[November 2012] We have seen a lot of pictures relating to the fences and locks used – or not used – by stations. But how secure is a tower base required to be? The answer may surprise you a bit..*

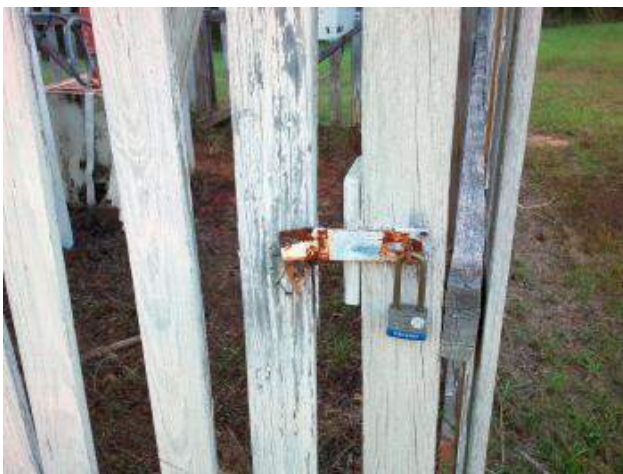
**Yes, there is a lock on this gate**

Ray Gorney kindly sent this picture, with the note that if one were to forget the key to the lock, a #2 Phillips screwdriver will work just as well.

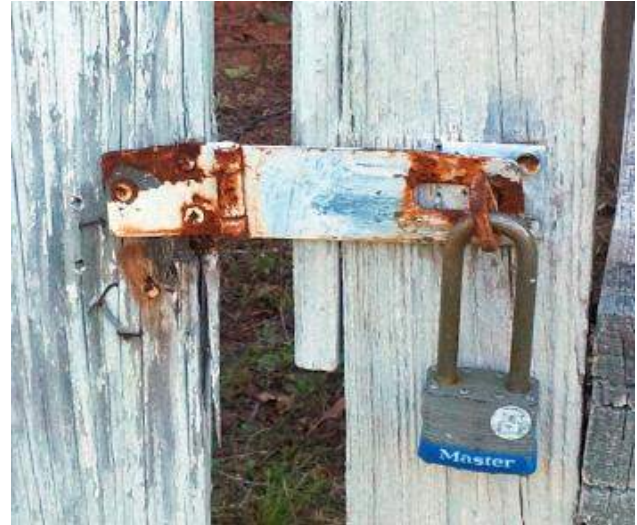
**This gate can be opened by either of two ways**

Now, here is the interesting part: just to be sure, we asked several inspectors from the FCC's Alternate Broadcast Inspection Program (ABIP) to take a look and tell us whether or not this fence and gate would pass inspection. The answer was ... yes.

The consensus was that the Rules do not say a locked fence must be impregnable – just that it must be locked.
