The Worst I've Ever Seen! **You Cannot Fight the Storm**

SO MUCH FOR SATURDAY NIGHT

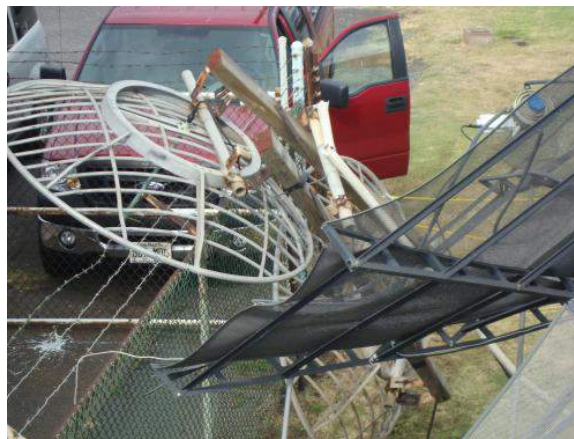
A nasty storm caused two STL dishes to fall down through the satellite receive dish

Welcker relates: "Basically there were two Mark dishes and a whip mounted on wooden cross members on top of a pole. Due to high winds the mounts worked themselves free falling through a paraflector, then through the satellite dish below all that."

Can we learn any lessons from this situation? Perhaps it is good to periodically review the condition of the STL and receive dishes used at a facility. Sometimes they can be strengthened, sometimes there is little that can be done, aside from making sure that if they break free, they will likely fall where they will not do damage to buildings or people.

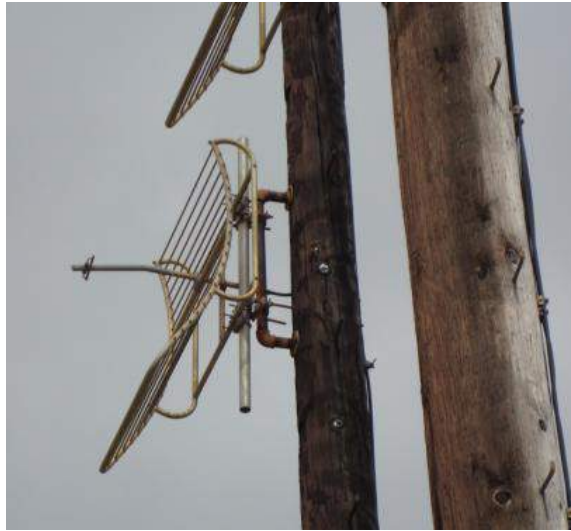
Two dishes remained attached to the poles but the ones that fell killed the satellite receive dish.

Curiously enough, one of the Mark dishes was feeding an AM station about eight miles away. Welcker was amazed to hear that despite some static, and the loss of the dish ripping “the inner out of the feed when it fell, just the transmission line and part of the inner [was left hanging] and it was still being picked up on the receive side. There was static as the wind would blow the cable past a pipe mount, still on the pole. Amazing how those things work.”

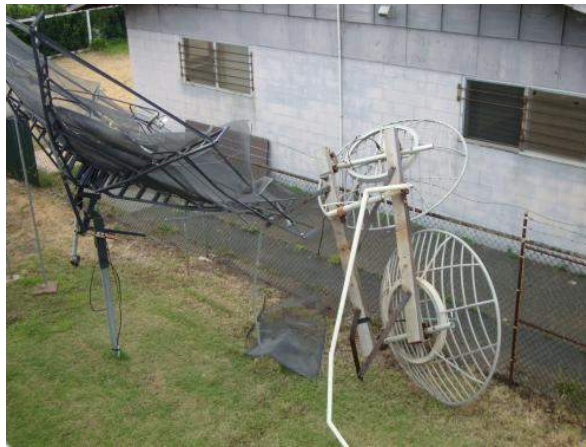
Viewed from another angle, not only is the damage visible, but we can see how close it was to where it might have hit someone.

At least the timing was good for the safety of the station personnel. As Welcker relates: “Luckily no one was around so there were no injuries, no damage to the building either, just equipment.”
